Manhole Inspection Summary

Manhole # S29M__035MH

Insp Date: **12/4/08 9:34 AM**

Location Address: **748 W.Hamburg St.**

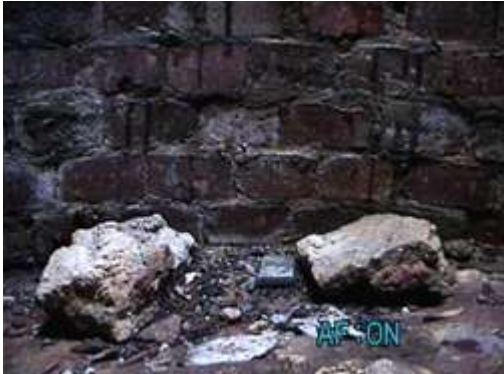
Miscellaneous

debris on the bench

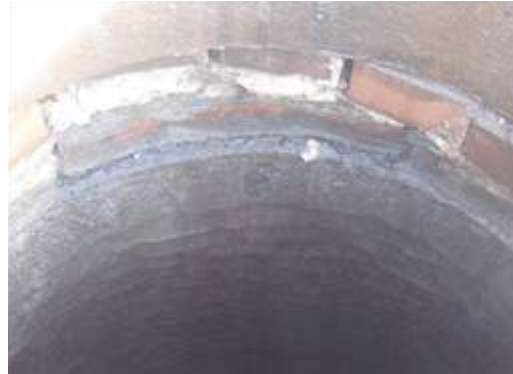
Defect 4

Condition: ☐ Sound ☐ Cracked ☐ Root Intrusion ☒ **Loose Brick** ☐ Deteriorated

Infiltration: ☐ None ☐ Joint ☐ Cracks ☒ **Mortar** ☐ Roots ☐ Wall

chimney has loose brick with infiltration coming from mortar

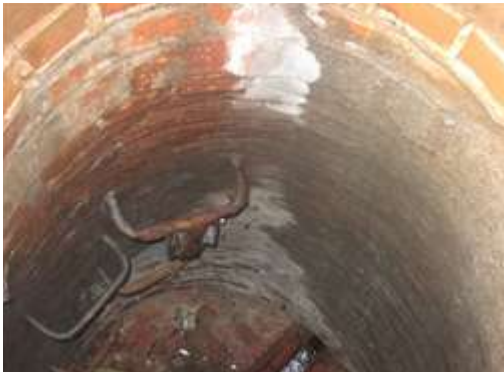
Defect 2

Infiltration: ☐ None ☐ Joint ☐ Cracks ☐ Mortar ☐ Roots ☒ **Wall**

infiltration from corbel & barrel walls

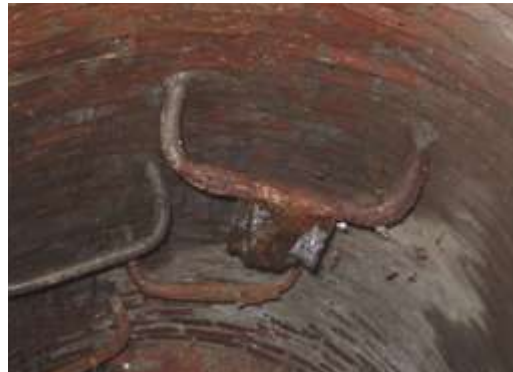
Defect 1

Count: **5** Missing: **0** ☒ **Corroded**

☒ **Evidence Of Surcharge** Depth: **4.5** (ft.) ☐ Active Surcharge Present

surcharge evidence on step, corroded steps

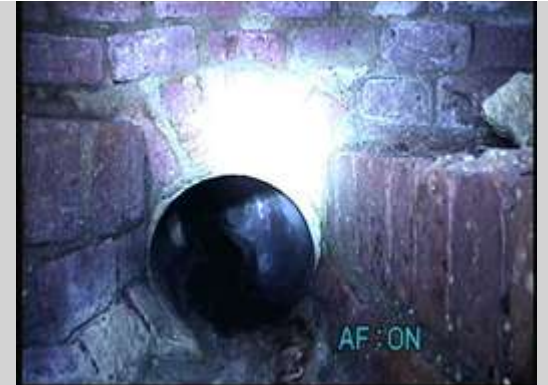
12 O'Clock Outflow

Pipe Height: **8.4** (in.) Rod and Bar (Angled)
Pipe Material: **Clay** ☐ Pipe Lined
Invert Depth: **10.63** (ft.) Flow Characteristics: **Slow**
Deposits: ☒ None ☐ Mud ☐ Sludge ☐ Debris ☐ Grease
Silt Depth: **0** (in.) Deposits Extent:
Infiltration: **None** Pipe Seal Cond: **Sound**

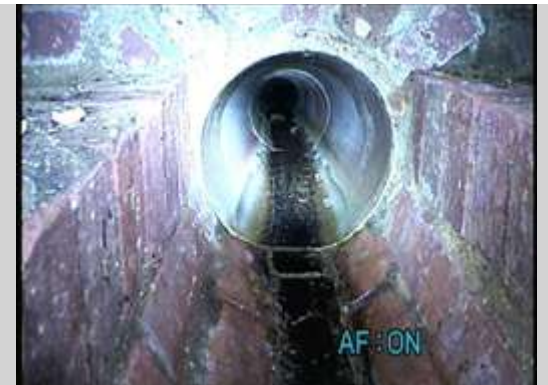
6 O'Clock Inflow

Pipe Height: **8.4** (in.) Rod and Bar (Angled)
Pipe Material: **Clay** ☐ Pipe Lined
Invert Depth: **10.04** (ft.) Flow Characteristics: **Slow**
Deposits: ☒ None ☐ Mud ☐ Sludge ☐ Debris ☐ Grease
Silt Depth: **0** (in.) Deposits Extent:
Infiltration: **None** Pipe Seal Cond: **Sound**

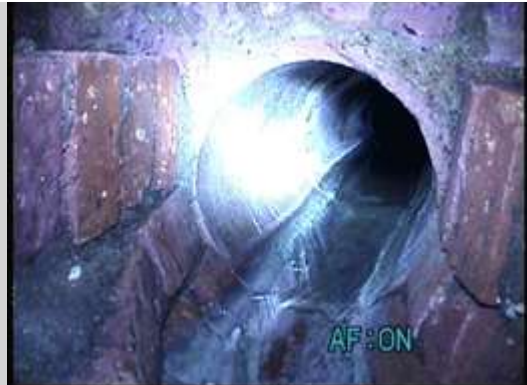
9 O'Clock Inflow

Infiltration: **None** Pipe Seal Cond: **Sound**
